Study of Improving Nurse Tank Safety

Research and Development Forum
January 17, 2014
Leonard Majors
PHMSA

Nurse Tank Safety Project

Iowa State University
December, 2008-August, 2013

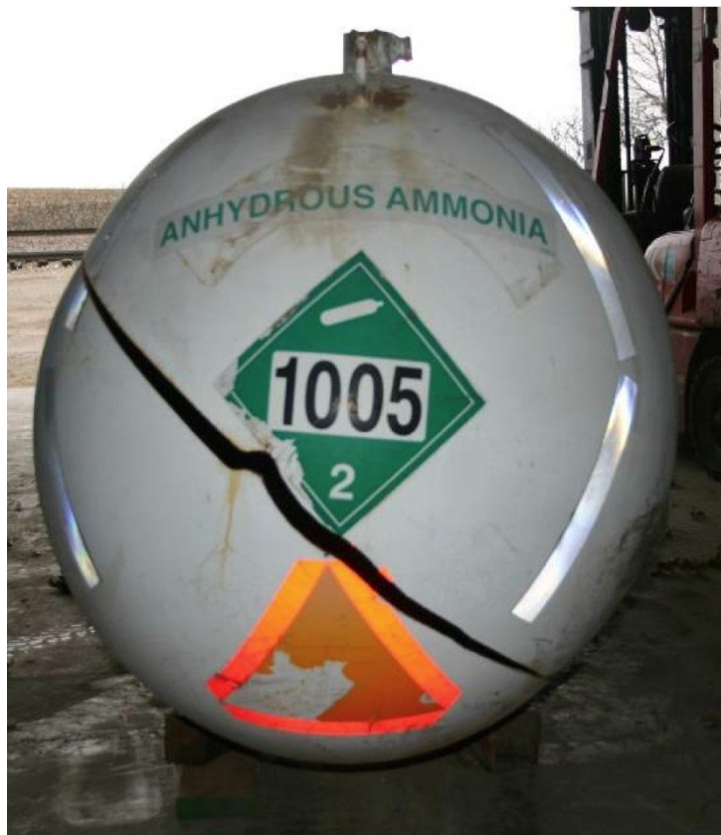
Many tanks in use are 40+ years old. Anhydrous ammonia is a corrosive that can cause *stress corrosion cracking* in steel.

If cracks become large enough, the pressurized tank can burst. Several ruptures have occurred, causing injuries and one death from inhalation of the ammonia.

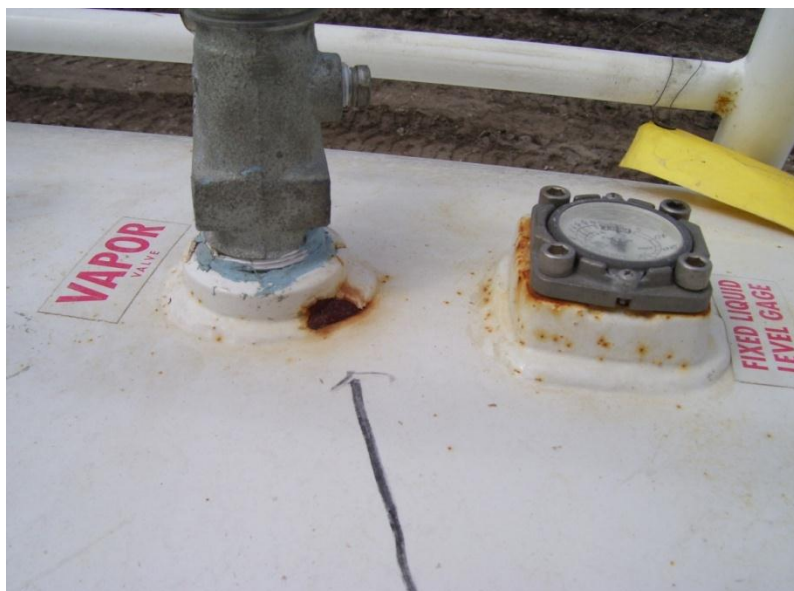
A very small fraction of the U.S. nurse tank fleet develops leaks in welds that slowly vent NH_3 into the atmosphere.

Weld porosity.

Very Unlikely. *Pinhole flaw sizes are much smaller than critical flaw sizes in these steels, even when the steel is chilled by rapidly expanding NH_3 . There was no indication of pinholes being connected to crack networks.*

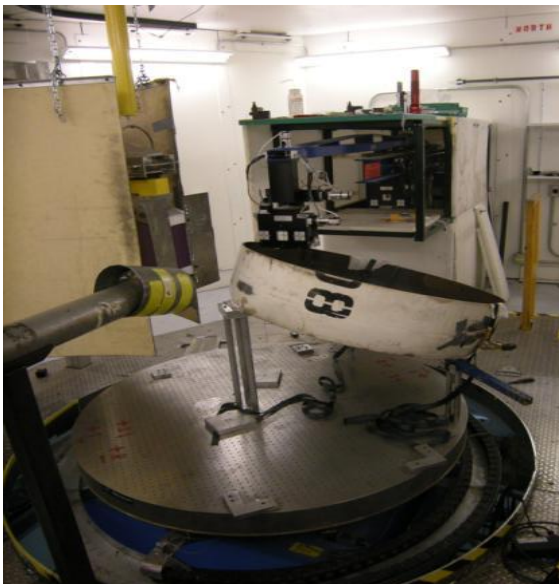
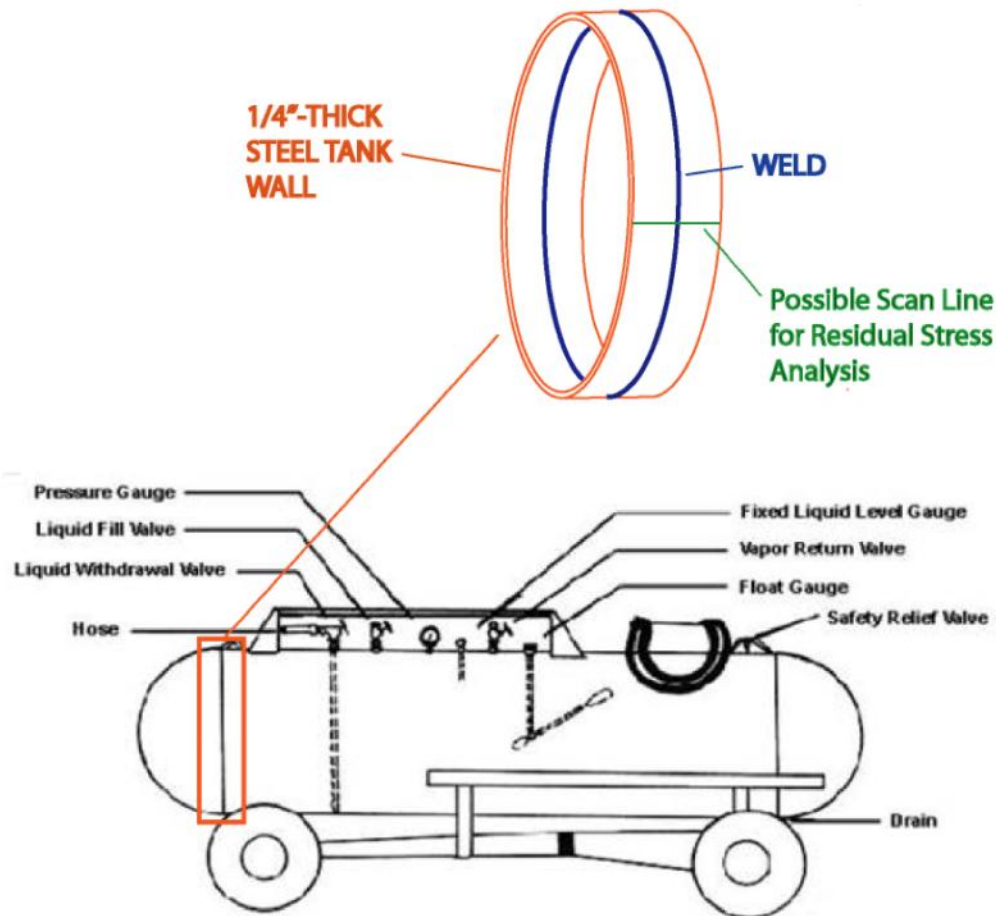
- Residual stresses around unannealed welds were found to be very high.

Residual stress in unannealed nurse tanks is very high – near the yield point of steel.

This high residual stress results from welding.

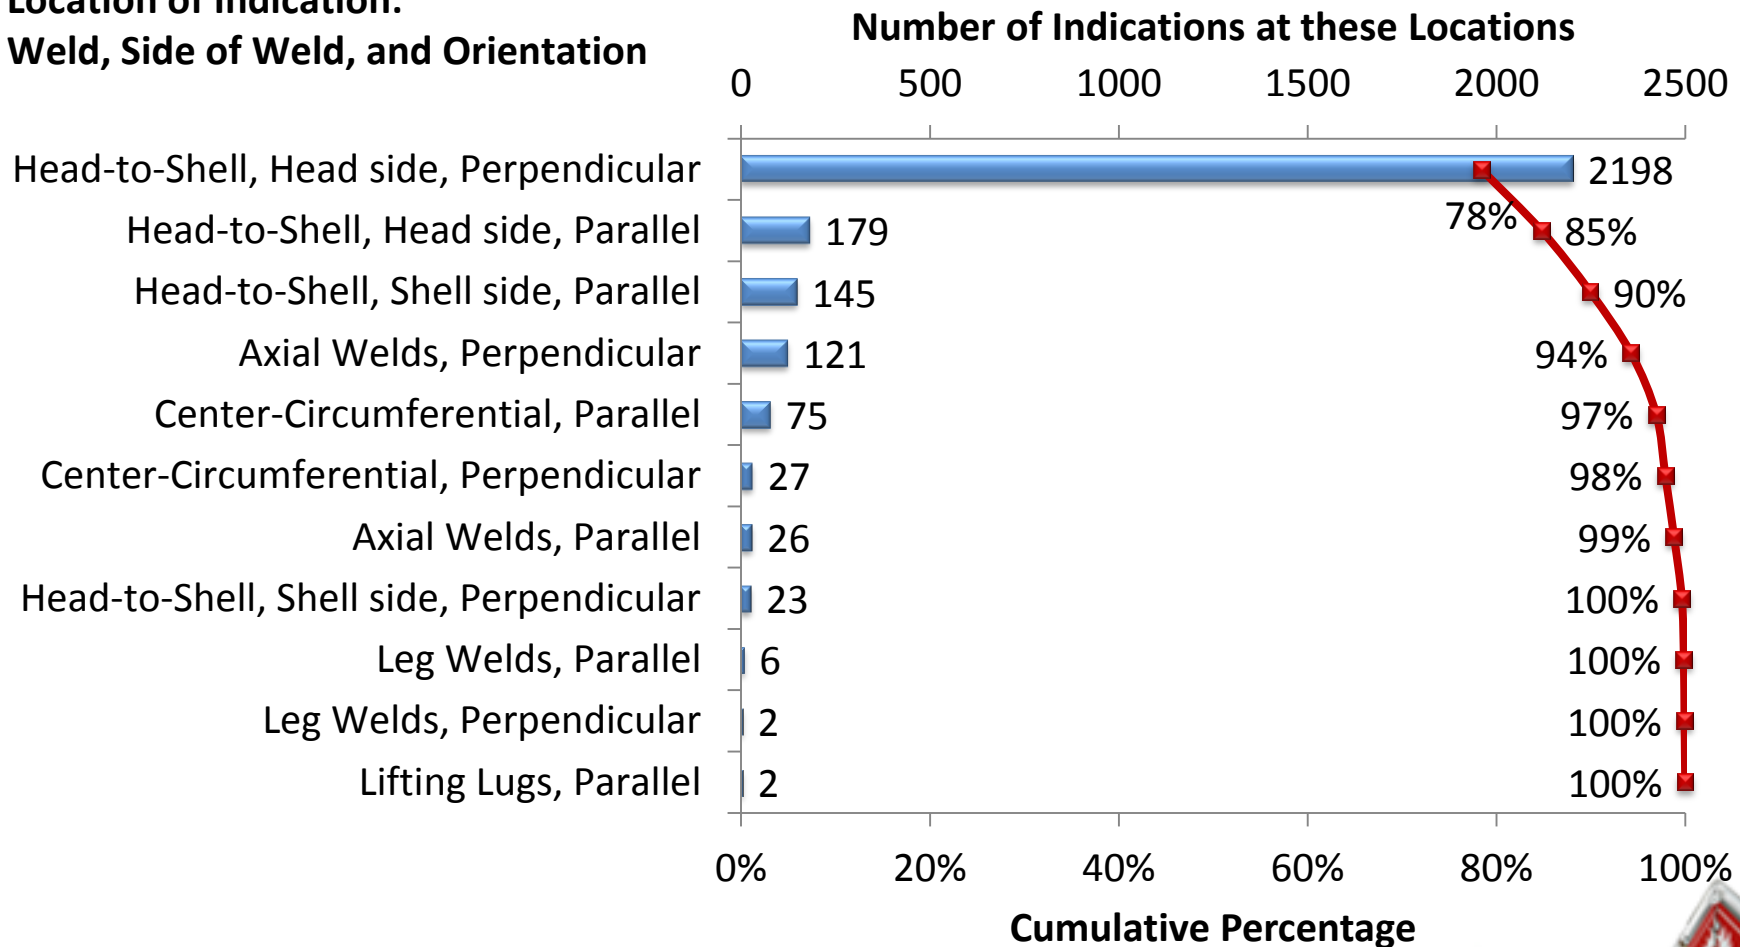
Location of Indication:

Weld, Side of Weld, and Orientation

- The circumferential welds that join the heads to the shell accounted for the great majority of indications, and most of those indications were located in the vapor space above the 80% fill line.
- The 168 tanks examined that were manufactured on or after 1999 with no annealing and thinner steel accounted for 74% of the indications found in the HAZ, even though those tanks comprised only 32% of the tanks examined.
